NAVWEPS REPORT 7905
NOTS TP 2912
COPY 95

EFFECT OF AERODYNAMIC-HEATING SIMULATION ON MARK 24 SIDEWINDER 1C SUSTAINER GRAINS

U. S. NAVAL ORDNANCE TEST STATION

September 1962

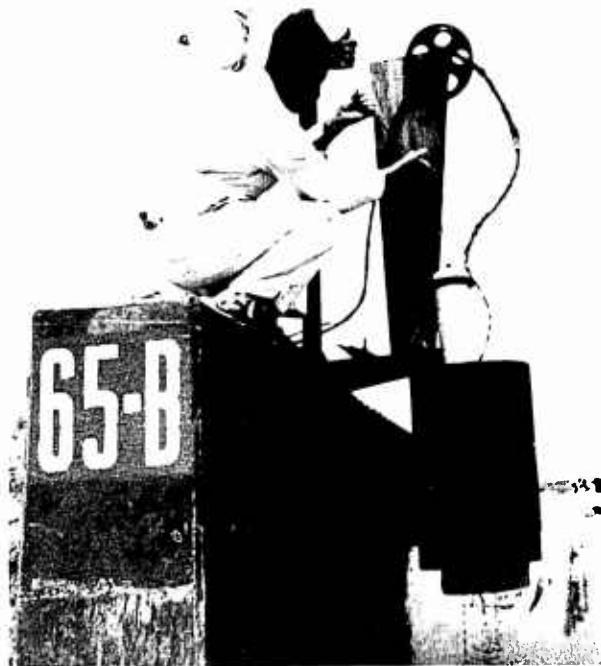
FIG. 1(b) Lowering Grain Into Insulating Jacket.

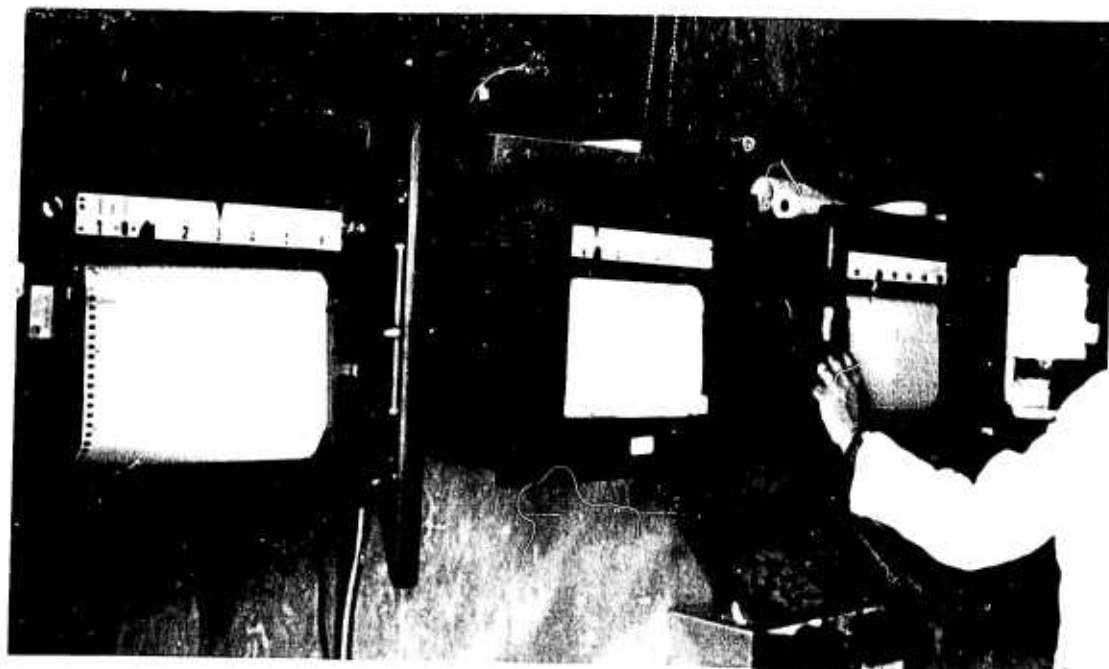
FIG. 1(d) Temperature Recorders.
